CALSPAN ON-SITE AMBULANCE CRASH INVESTIGATION

SCI CASE NO: CA09082

VEHICLE: 2004 FREIGHTLINER 2500 SHC / MEDIX TYPE II AMBULANCE

CRASH DATE: OCTOBER 2009

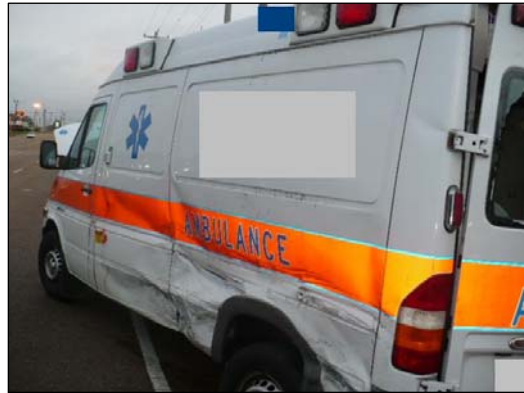
This on-site investigation focused on the severity of the crash and source of injury to the occupants of a 2004 Freightliner 2500 SHC cargo van converted into a Type II ambulance by Medix Specialty Vehicles, Incorporated (**Figure 1**). The Freightliner was involved in a left side impact crash with a 2006 Dodge Ram 1500 series pickup truck with a subsequent rollover. The one-quarter turn rollover event was interrupted as the top rear aspect of the Freightliner struck a non-breakaway utility pole as it slid on its right side. The crash resulted in the death of a 78-year-old female patient. All other occupants were injured in the crash, including a 25-year-old male Emergency Medical Technician (EMT) driver of the ambulance, a 20-year-old male EMT passenger in the patient compartment of the ambulance, and the 57-year-old male driver of the Dodge.

Figure 1: Involved ambulance.
(Image courtesy of the ambulance company)

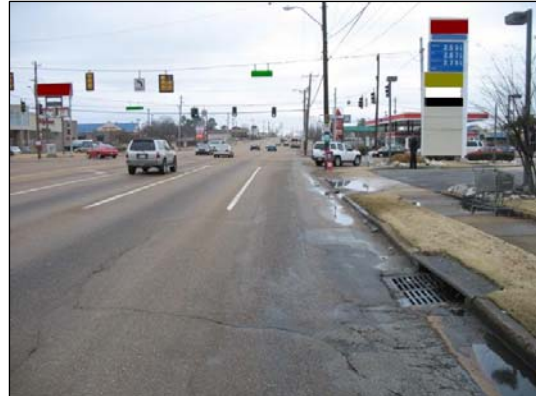
Figure 2: Northbound trajectory view of the crash site.

The Freightliner struck a wooden utility pole that was located 0.8 m (3 ft) east, and 8 m (26 ft) north of the northeast quadrant of the intersection. **Figure 2** is a northbound trajectory view approaching the intersection. A schematic of the crash is included as **Figure 15**.

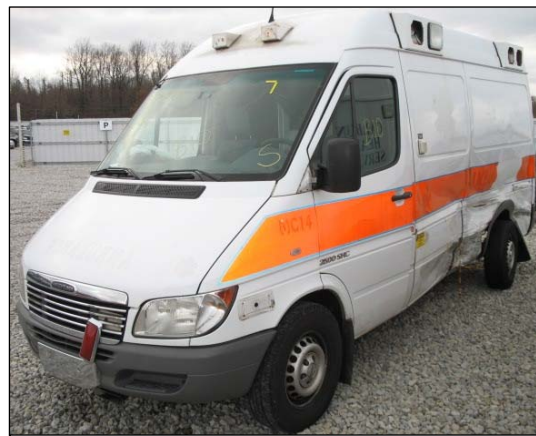
The ambulance chassis was a 2004 Freightliner 2500 SHC cargo van, depicted in **Figure 3**. The vehicle was manufactured in September 2004 and was identified by the Vehicle Identification Number (VIN): WD2PD644545 (production sequence deleted). The digital odometer reading at the time of SCI inspection was 278,814 km (173,247 miles). The Freightliner was manufactured as a complete vehicle with a two-door cab, two center closing rear doors, and a right side sliding door.

Figure 3: Front left oblique view of the 2004 Freightliner ambulance.

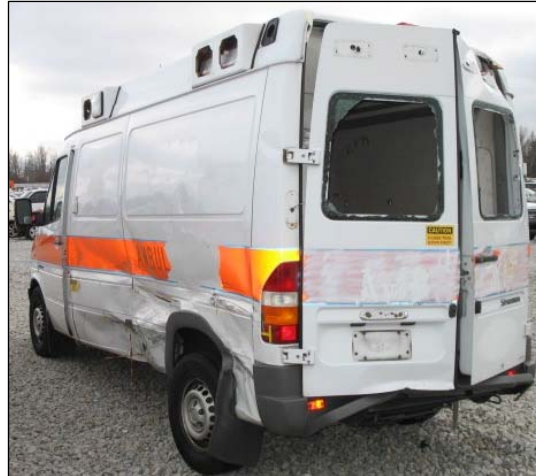
at the front and rear aspects of the sides at the roofline. Compartment ventilation ports were located at the upper rear aspect of both sides. A shoreline electric power connection plug was added to the left side, mid level, aft of the B-pillar. **Figure 4** is a back left exterior view of the Freightliner Type II ambulance.

Figure 4: Left rear oblique view of the Freightliner ambulance.

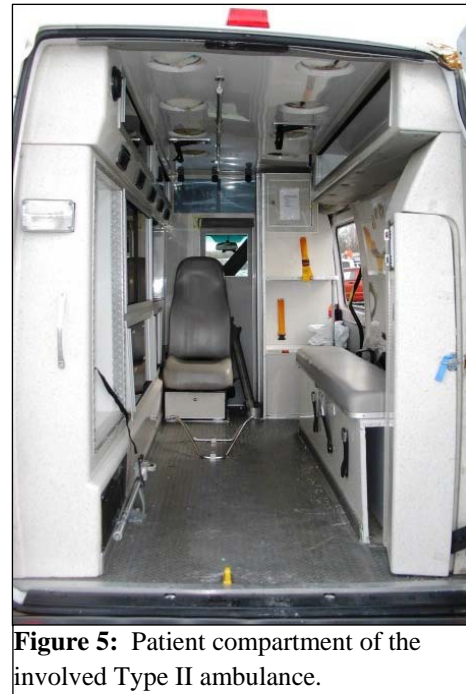
Figure 5: Patient compartment of the involved Type II ambulance.

anchoring system consisted of a forward antler bracket that straddled the wheels and frame at the head of the stretcher, with a rail clamp that secured the rear aspect of the stretcher. When loaded into the ambulance, an anchor pin located on the foot of the stretcher would insert into the rear bracket of the clamp and activate the spring-loaded mechanism, which would lock the stretcher in place for transit. **Figure 5** is an overall image of the interior of the ambulance.

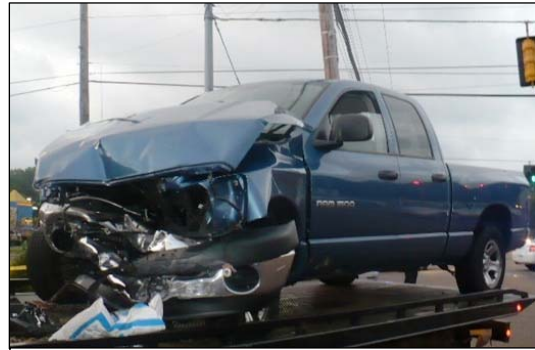
The 2006 Dodge Ram 1500 was identified by the Vehicle Identification Number (VIN): 1D7HA18K36J (production sequence deleted). This quad cab pickup truck was rear-wheel drive and was powered by a 3.7-liter, V-6 gasoline engine. The Dodge had a 357 cm (140 in) wheelbase, and was 571 cm (224 in) in overall length. The Dodge was equipped with a redesigned frontal air bag system consisting of a steering wheel hub-mounted driver air bag and a right instrument panel-mounted passenger air bag. The front seats were equipped with 3-point lap and shoulder safety belts for manual restraint with ELR/ALR retractors and pretensioners. The rear safety features are unknown. The Dodge was sold at auction prior to the assignment of this case; therefore, the vehicle was not inspected. **Figure 6** is a front left oblique view of the Dodge the involved Dodge Ram as it was towed from the scene of the crash.

Figure 6: Involved 2006 Dodge Ram pickup truck.
